Assessing the Technical Condition of a War-Damaged Residential Building in Ukraine Based on Integrated Geodetic and Photogrammetric Surveys

Mykhailo Yakovenko, Olena Nesterenko, Dmytro Stelmakh, Kostiantyn Babik, Yevhen Zorin, Ihor Ben, Iuliia Horkovchuk

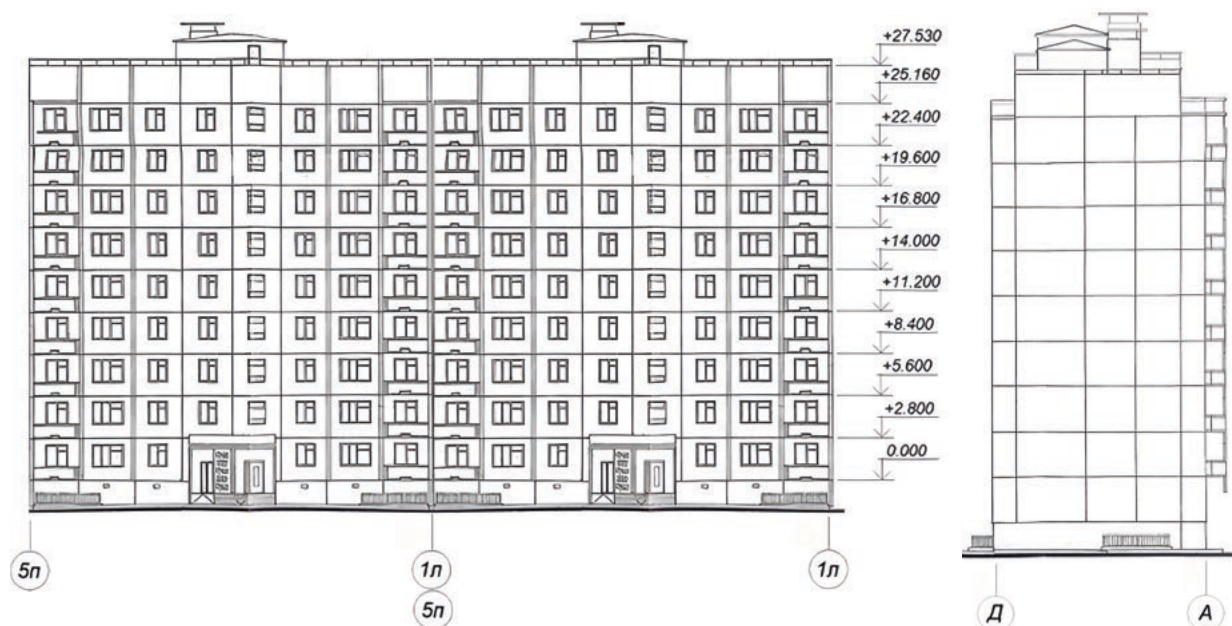
Fig. 3 | View of the courtyard and end facades of the residential building

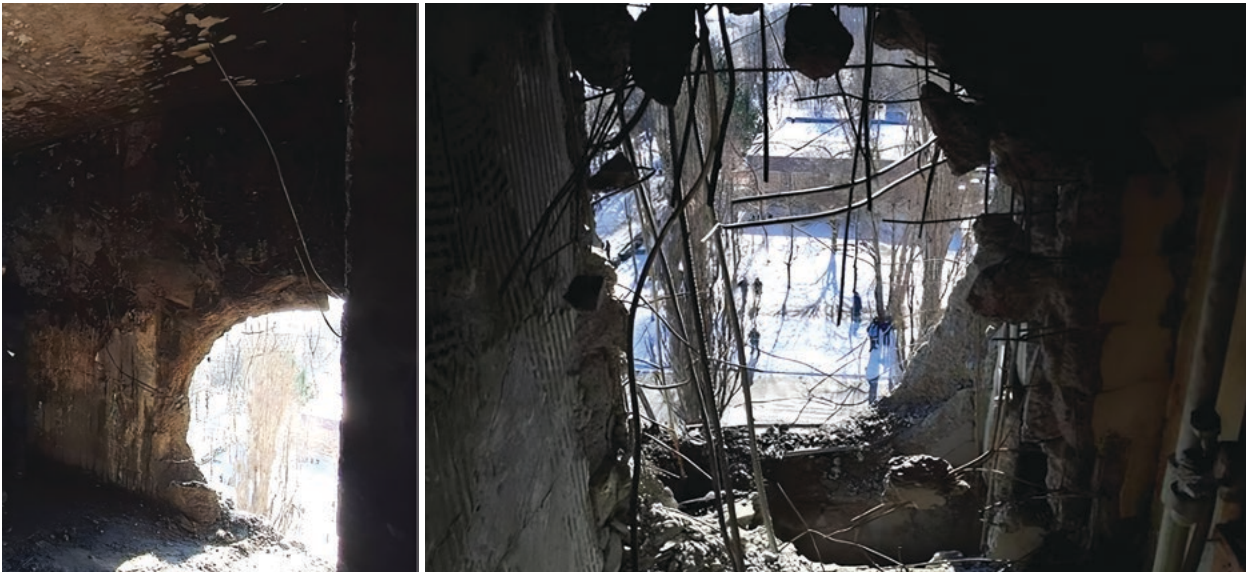
Fig. 4 | The image of opening in the wall panel of the 8th floor at the UAV impact place

A direct hit by a combat UAV on the side facade of section 1-2 at grid axes 1L/V on the level of the 8th floor caused the following damages:

- mechanical damage to external and internal walls caused by the UAV warhead explosion and the subsequent fire;
- damage to wall panels and floor slabs of apartments due to the fire;
- initiation and propagation of existing cracks in wall panels and floor slabs as a result of the intense impact from the explosion;
- damage to the building's structural connection nodes due to the dynamic explosion effect;
- displacement of wall panels relative to their design positions due to the explosion;
- damage to finishing layers of external and internal walls, floors, and ceilings;
- full or partial destruction of glazing in windows and balconies caused by the blast wave and debris;
- damage to doors and interior property resulting from the explosion and fire;
- partial damage to water supply, sewage, and ventilation systems in some apartments of section 1-2.

The point of impact of the combat UAV was on the end wall of the eighth floor of section 1-2, creating a through opening in the external wall and causing a fire (see Fig. 4).

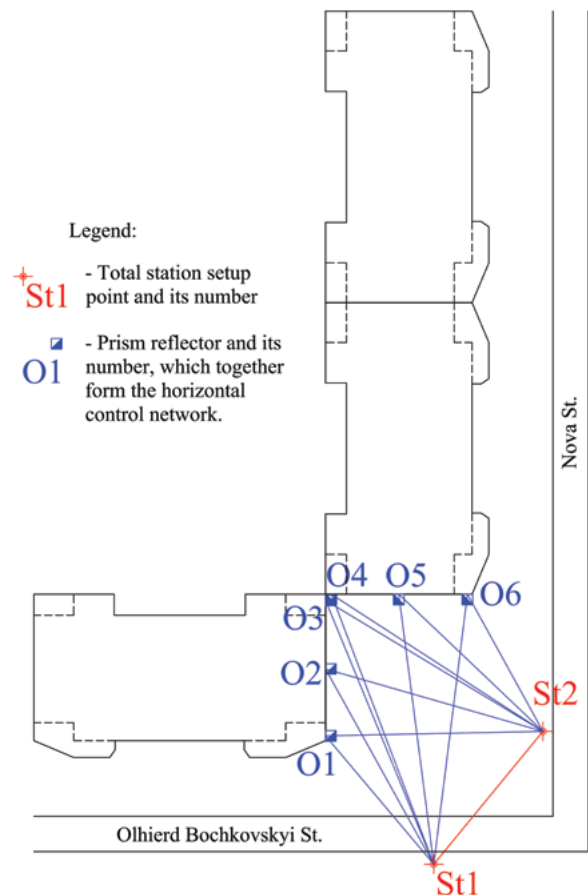
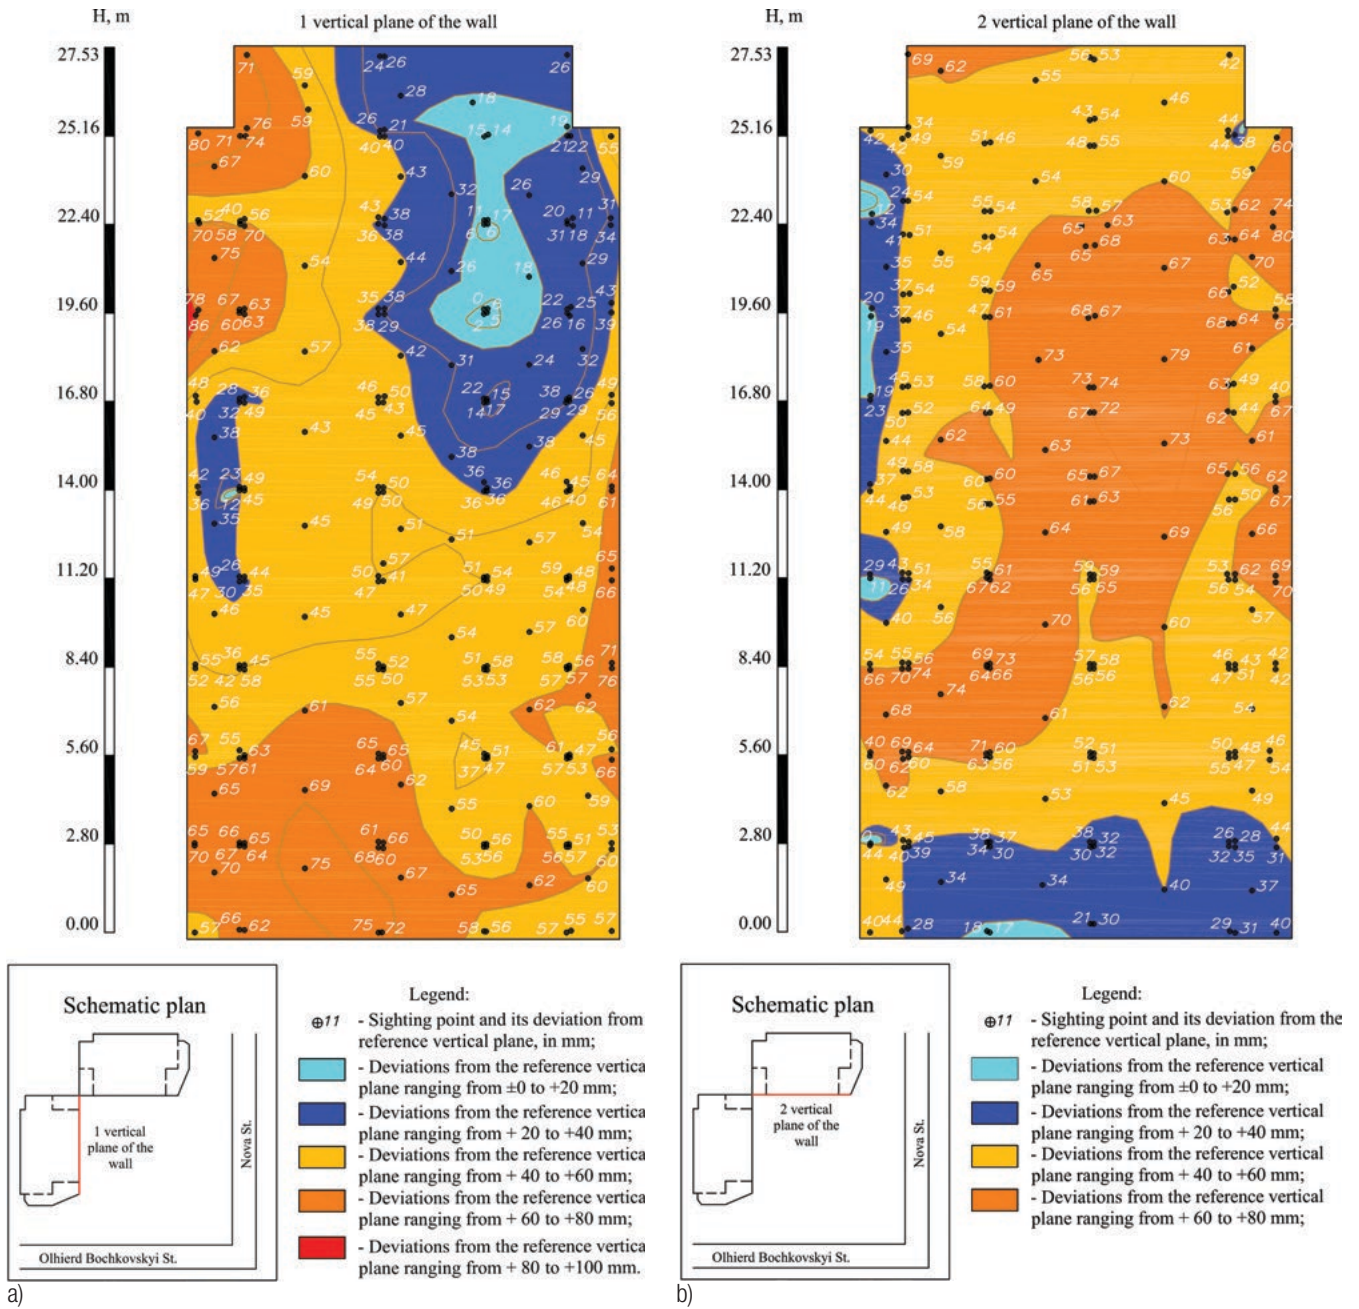
Fig. 8 | Results of determining vertical deviations of the a) wall in section 3 and b) wall in section 1-2

All presented values have a positive sign (“+”), indicating that the direction of deviation is towards the surveying station. The geodetic survey was conducted on March 27, 2025, so the indicated deviation values reflect the actual condition of the structures at that time.

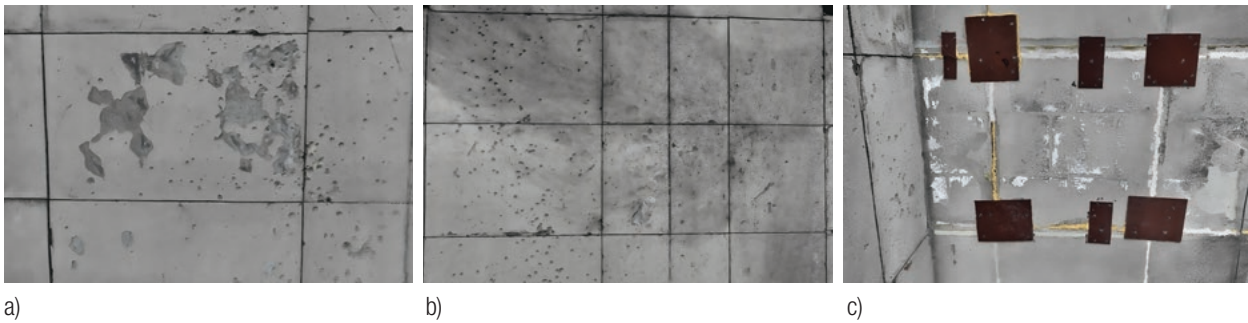
Fig. 11 | Defects and damages identified based on photogrammetric model data: a) spalling of concrete on exterior walls caused by explosion debris, b) propagation of the blast wave, c) damage to embedded parts and opening of interpanel joints

Fig. 11 shows the defects caused by the explosion and fire of a combat UAV. The remote inspection carried out enabled the assessment of the damage, measurement of its dimensions (Fig. 12), and detailed classification of the defects, which served as a basis for developing recommendations for further restoration.

Analysis the data from the photogrammetric models revealed visible defects: spalling of the concrete on the exterior walls, the spread of the explosion wave and fire, burnt areas of the building, damage to embedded parts, and the opening of inter-panel joints. The area of surface damage of various types reached 27.8 % of the total external wall surface area of sections 1-2 and 3.

These defects may affect the structural integrity of the building. The results enable timely safety measures to be taken and allow for the rational use of the acquired data to make informed decisions regarding the restoration of the residential building.

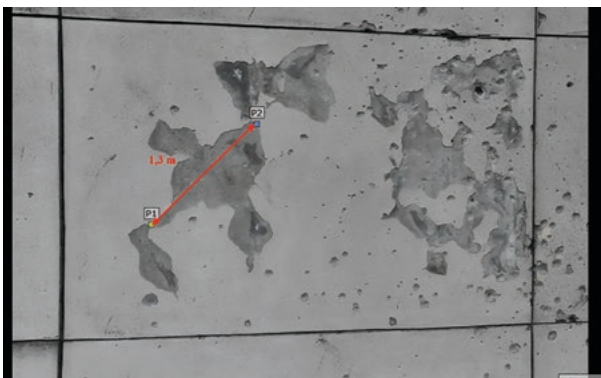
Fig. 12 | Determination of a characteristic facade defect dimension using photogrammetry
